Propulsion Health Monitoring for Enhanced Safety

General Electric Company, Aircraft Engines, Cincinnati, Ohio

General Electric Company, Global Research, Niskayuna, New York

The “Propulsion System Health Management for Enhanced Safety” contract was performed under the Propulsion System Health Management Element of the NASA Aviation Safety Program. The objective of this contract was to develop and demonstrate candidate engine health management technologies for enhanced aviation safety. The technologies included a General Electric Global Research (GE GR) radial-mode vibration disk crack detection system, a Pennsylvania State University Applied Research Laboratory (PSU ARL) torsional-mode vibration disk crack detection system, and a General Electric Aircraft Engines (GE AE) Model-Based Fault Tolerant Control system. The two disk crack detection technologies are potential diagnostic approaches for the automated on-line detection of turbine rotor disk cracks through the noninvasive monitoring of vibration measurements. The objective of these technologies is the early detection of disk cracks prior to their propagation to a critical size where the engine is at risk of an uncontained ro

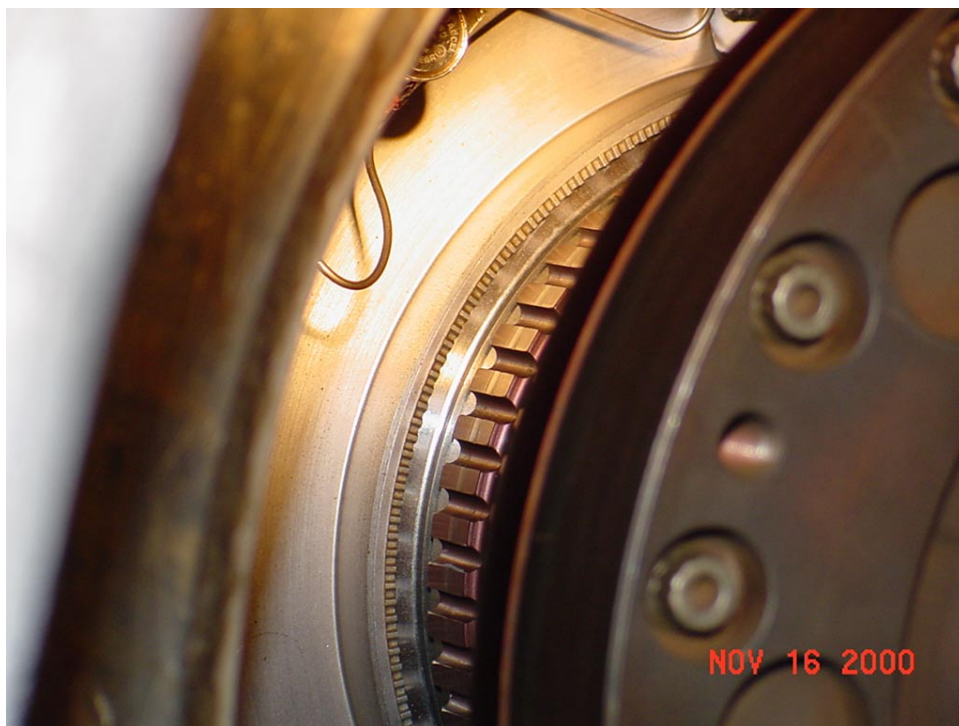
Figure 55. 60-Tooth Speed Gear

In addition, signals were taken from the warm air test apparatus, including the one-per-rev tachometer and the 60-tooth speed gear. The tachometer was required for the signal processing algorithms, and the 60-tooth gear was used as backup for the encoded tape. Figure 55 shows the gear. Note that the gear is actually located slightly closer to the HPT disk than the encoded tape.
